Discussion of Tubular Steel Monopole Base Connections: The Base Weld Toe Crack Phenomenon: Crack Identification and Proposed Severity Classification System

<p>By: Brian R. Reese, PE, CWI President Reese Tower Services</p>	<p> David W. Hawkins, PE Vice President Paul J. Ford & Company</p>
--	---

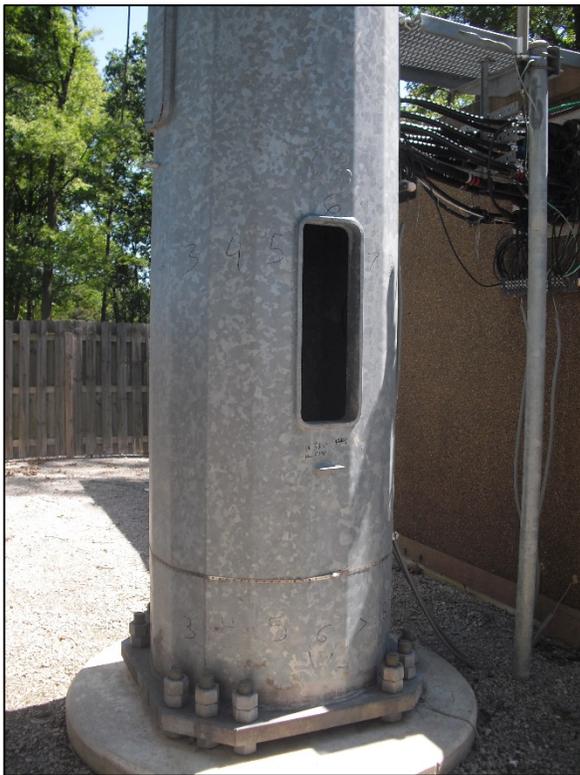
Typical Communications Monopole Base Connection

The connection detail of the pole shaft to the base plate can vary depending on the type of pole and/or the manufacturer. Typical pole base connection weld details include complete joint penetration groove weld (CJP) and socket style (double fillet weld) connections as shown in the figures below. The CJP connection base plate is butted against the pole shaft and consists of a circumferential single-bevel groove weld with 100% complete weld penetration (CJP) and a reinforcing fillet weld. In other words, the connection zone is all weld material. This connection style is very popular (especially for polygonal poles), a cost economical method of fabrication, and traditionally the base connection of choice for most major pole manufacturers. The socket connection base plate sleeves over the pole shaft and is welded with double fillet welds above and below the sleeved base plate. This connection is also popular due to the fact that the welds are simple fillet welds and a non-destructive examination (NDE) ultrasonic test is not performed on this joint post-fabrication reducing quality assurance costs. The socket connection is easier to fabricate for a round pole than for a polygonal pole. While other joints may be possible (including shop welded base plate stiffeners), the majority of anchor-based poles manufactured fall into one of these two base joint categories.

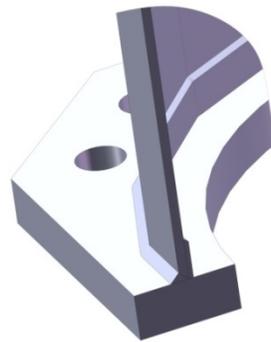
Complete Penetration Joint (CJP)

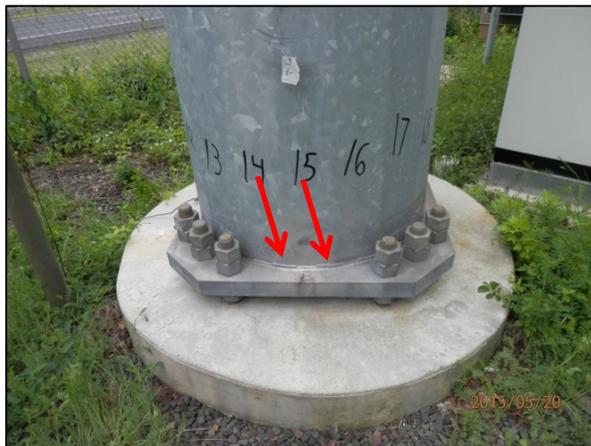
Manufacturer Toe Crack Repairs Visible in the Field

The phenomenon of toe cracking is not new and has been observed within the pole industry since the 1970’s. ANSI/NEMA TT 1 “*Tapered Tubular Steel Structures*” (1983) in Section 10.5 states that “*Shaft to base plate welds shall be inspected by the ultrasonic method for evidence of cracking in the shaft or base plate heat affected zone.*” The American Society of Civil Engineers (ASCE) Manual 72, “*Design of Steel Transmission Pole Structures*,” 2nd edition (1990) states in Section 3.5.3.3 Special Design Considerations “*Toe cracking of weldments: Toe cracks, around T-joint welds, undetectable prior to galvanizing have been detected after galvanizing. The formation of these cracks appears to be influenced by several factors in the fabrication process. Requirements for post-galvanizing inspection should be considered.*” Most pole manufacturers inspect for toe cracks after the galvanizing process as a normal part of their quality assurance program. In instances where preventative field inspections have been performed on the base plate weld connection while in service, cracks have been found in the pole shaft at the upper toe above the base plate weld. This has occurred on multi-sided (polygonal) and round poles in both complete joint penetration (CJP) groove weld and socket base plate connections. Toe cracks in polygonal poles typically first occur near the vertices (bend-lines or “points” of the multi-sided shaft) since this area generally has a higher stress concentration.

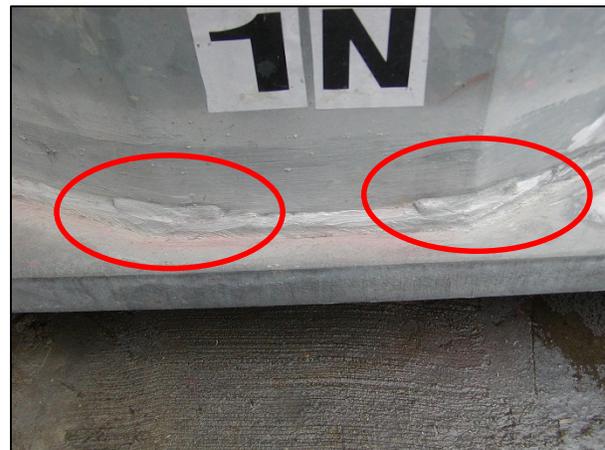
Manufacturer Repair or Reinforcement of Upper Toe of Base Weld Observed in Field

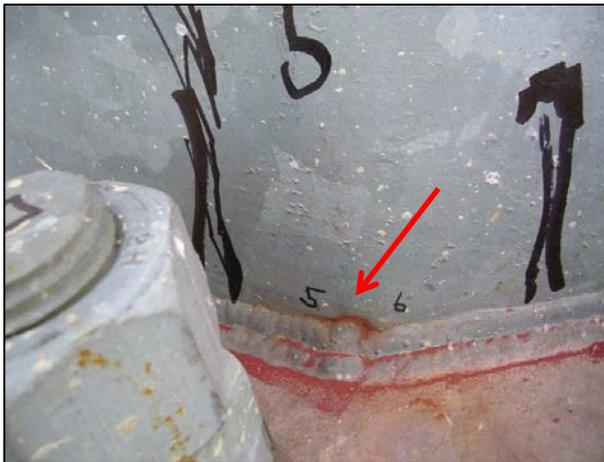
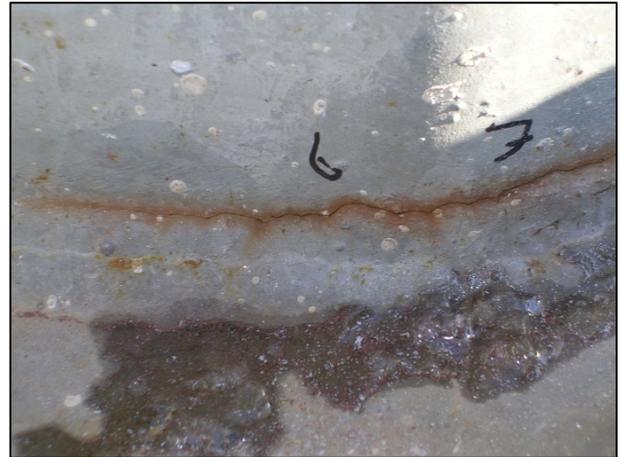
Toe Cracks at Upper Toe of Weld in Pole Shaft at Polygonal Bend Line (Visible Rust)

1. In the most severe cases, visible with the naked eye 'wandering' along the upper toe of the weld on the press bend line between two flats on a multi-sided pole (see photos below)
2. Identified with magnetic particle (MT) testing at surface or near-surface, but not visible with naked eye
3. Identified with ultrasonic testing (UT) but not identified with magnetic particle (MT) testing or visible with naked eye
4. Ranging from one location only to each bend line of the pole base section
5. Varying from fractions of an inch to multiple inches in length
6. Depths ranging from thousands of an inch to clear through the base wall thickness (see photo below)
7. Significant bleeding rust observed at the crack at the upper toe of the weld can indicate the crack is completely through the pole shaft thickness

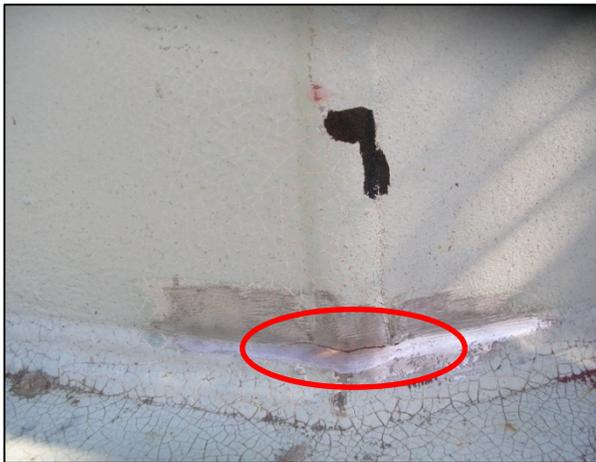
Minor Toe Crack Visible via MT Powder after Light Grinding

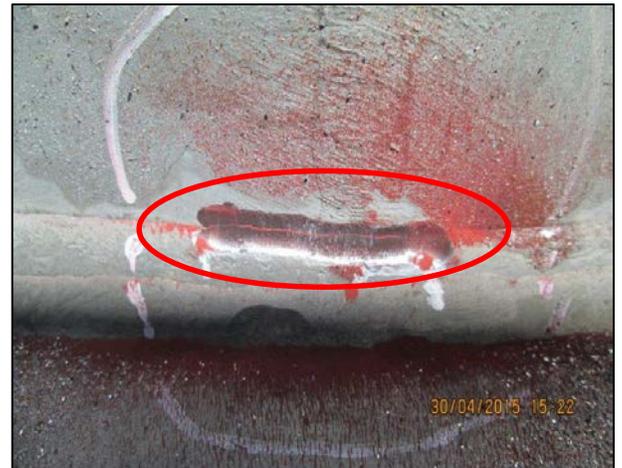
Toe Crack Still Visible via MT Exam after Grinding

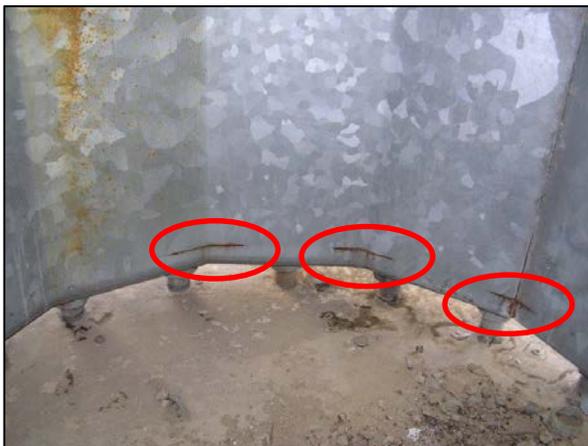
Socket Style Pole Base Through-Wall Toe Cracking Viewed From the Inside of the Pole (Visible Rust)
