Reese's

PIECES

RTS specializes in providing weld inspections, mappings, and condition assessment services to the tower & pole industries

Welding Defects – Cracks

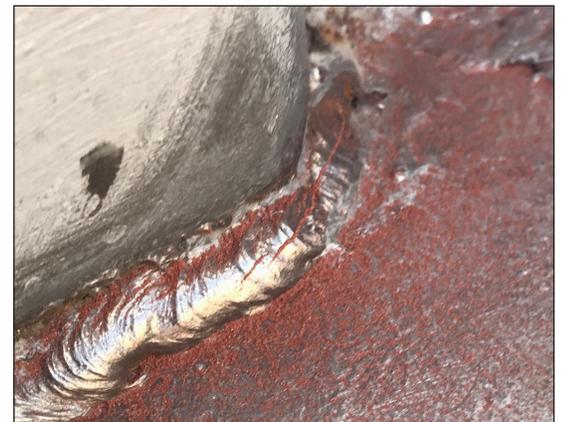
Significant cracking in a welded joint can be identified visually. Bleeding rust can be a giveaway of the presence of a crack. Magnetic particle non-destructive examination is commonly used to detect small surface cracks that are not visible to the naked eye in welded connections.

While there are some gray areas related to inspector judgment in weld inspection, this subject is straightforward. AWS D1.1 Table 6.1 prohibits cracks – any crack is unacceptable,

regardless of size or location. A crack, when not repaired, can result in the catastrophic failure of a structural connection. Monopole non-destructive base weld inspections are performed with the intent of locating cracks at the critical base plate to pole shaft weld connection. □

Cracks can occur in the weld metal zone, heat-affected zone, and base metal when localized stresses exceed the ultimate strength of the material according to AWS B1.10. Cracking often initiates at stress concentrations caused by other discontinuities or near mechanical notches associated with weld joint design. Stresses that cause cracking may be either residual or service induced. Residual stresses may pre-exist in base metal or be from the fabrication process.
