## **COMMUNICATIONS POLE INSPECTION & MAINTENANCE PROTECT YOUR ASSETS & PROLONG THEIR LIFESPAN**

Brian Reese, P.E., CWI  
President, Reese Tower Services

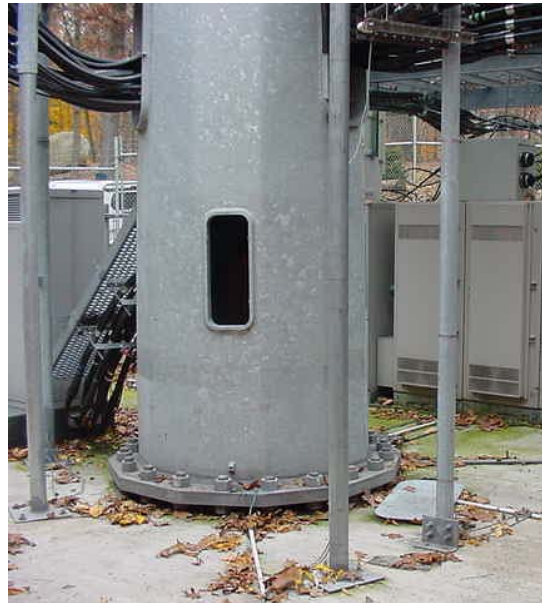
Various communications pole base details:

- Complete joint penetration groove weld – the base plate is butted against the pole shaft and consists of 100% complete weld penetration. In other words, the connection zone is all weld material.
- Socket base plate connection (base plate sleeves over pole wall) with double fillet welds.

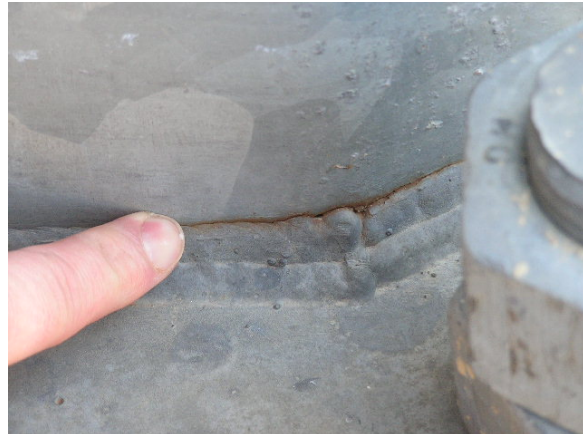
A crack in a weld or base metal is a break in a material that was solid previously and separated due to stress. Cracking occurs in a weld and base metal when the localized stresses at the connection exceed the ultimate strength of the steel material. Left in place without repair, cracks may propagate over time and loading and can be very detrimental to structural adequacy. The American Welding Society ([www.aws.org](http://www.aws.org)) Structural Welding Code D1.1 does not allow a crack to be left after inspection (Table 6.1, Part 1), regardless of size or location.

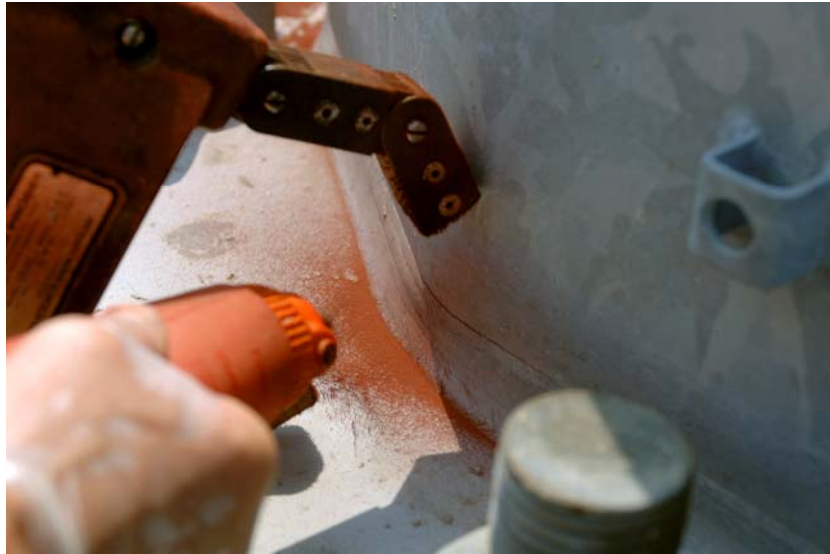
3. NDT Magnetic Particle Testing – Conducted by an inspector with American Society for Non-Destructive Testing (ASNT – [www.asnt.org](http://www.asnt.org)) Level II Certification. This non-destructive test is utilized to assess surface cracks in joints that are not 100% complete penetration joints; i.e. socket base plate connections. Defects hold the magnetic particle material during the test and identify the presence of a crack. The crack in the picture below can be seen holding red powder.

***Magnetic Particle Test (MT) Powder at Revealing Toe Crack***

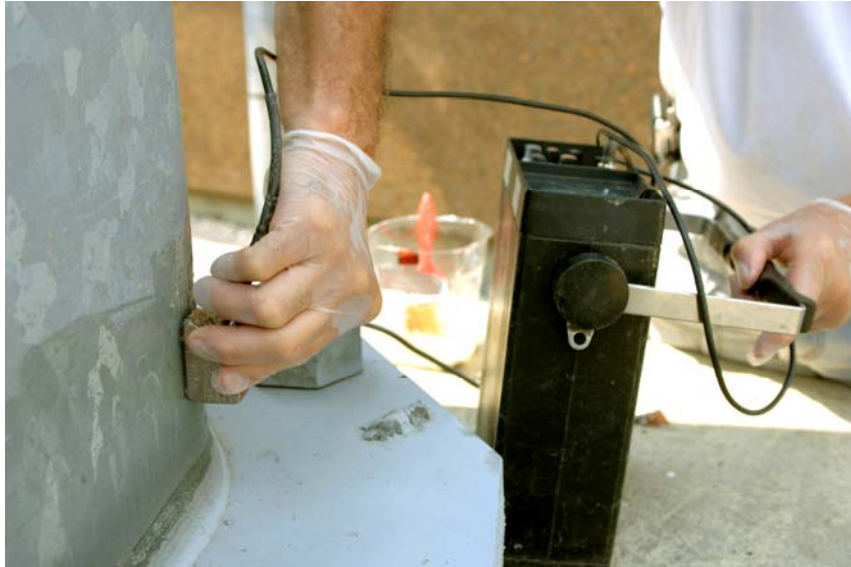
4. NDT Ultrasonic Testing – Also conducted by an inspector with ASNT Level II Certification. Utilized for testing of joints that are 100% complete penetration joints. The test utilizes ultrasonic waves that are interrupted by any material inconsistency (crack) in the joint.

***Ultrasonic Test (UT) of Pole Base Plate Weld***

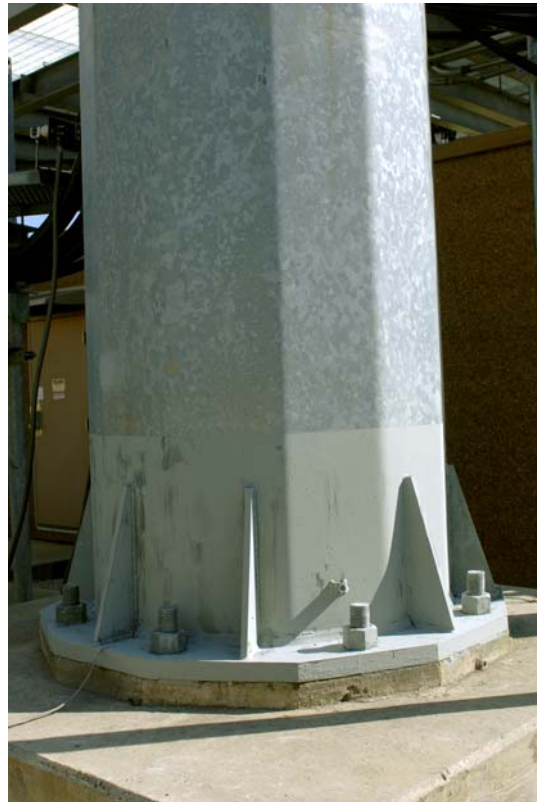
7. Assessment of Defects – Assess extent of cracks, length, and position
8. Defect Repair - The last stage is to repair the weld and/or reinforce the pole base connection. The scope of the strengthening stage will depend on the results of the diagnosis and analysis stage. Significant cracks may require drilled terminations. A reinforcement stiffener installation is shown at the right.
